CASE HISTORY #14

Asphalt Lagoon

Project: Liner, Durham Wastewater Retention Pond, Oregon

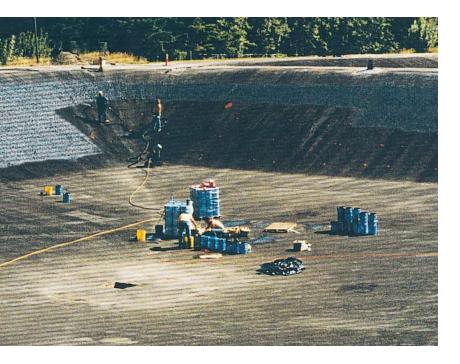
In 1990, the management at the Durham Wastewater Retention Pond in Durham, Oregon, had a decision to make: line their badly eroded pond or do nothing and face complete liquid retention failure.

In 2001, Clean Water Services of Hillsboro, Oregon, called for an inspection of the then eleven-year old liner. When the pond was drained, the liner was shown to be in good condition and performing well. After years of service, the CIM 1000 was still bridging substrate cracks and providing a flexible, resilient barrier.

The preparatory work consisted of pressure washing the asphalt to clean the surface and remove the deteriorated substrate. Two 30 mil coats of CIM 1000 were then applied to the sides of the pond using an air-assisted airless pump system. After the sides were lined, the pond base was coated using squeegees, and the project was complete.
